Mary Lake Nature Sanctuary — Lake Stewardship Project

Royal Roads University B.Sc. Environmental Science

ENSC 420 — Major Project

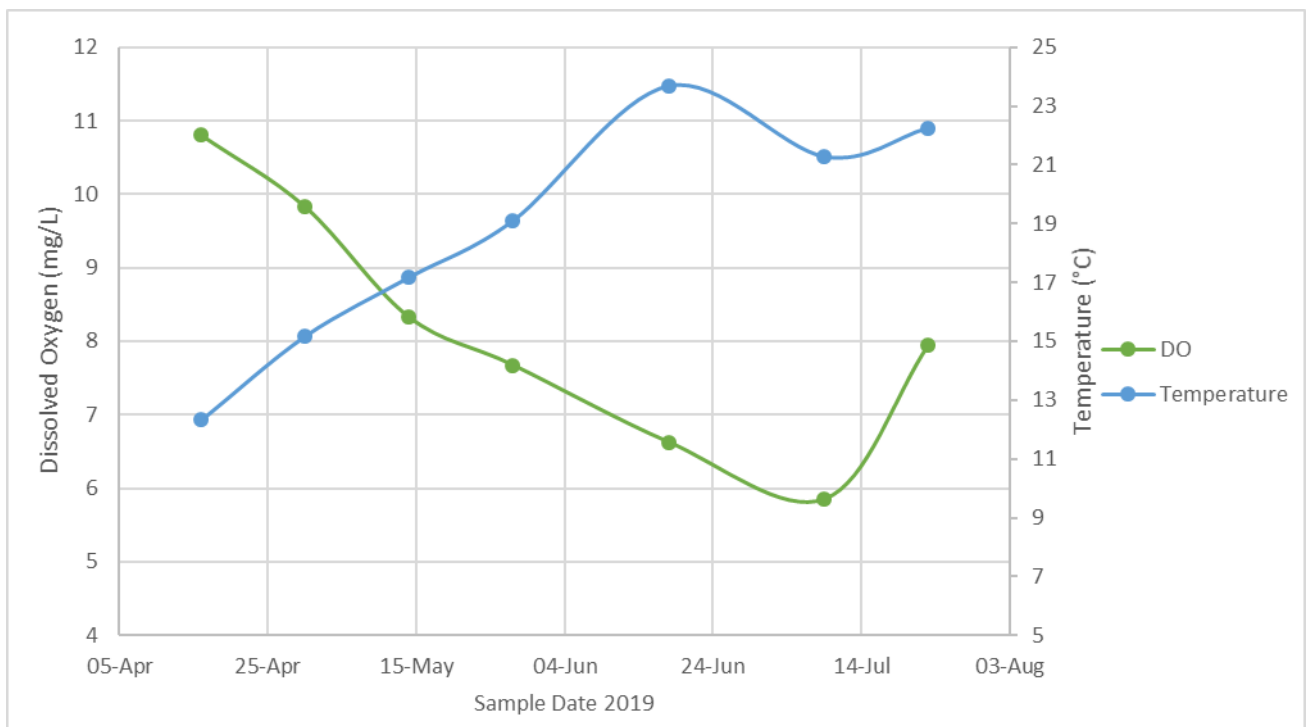
Figure 1: Average dissolved oxygen and temperature measurements from the surface of Mary Lake from April 16, 2019 to July 23, 2019 sampled using a Cole-Parmer probe.

The seasonal pH levels of the lake water and surrounding creeks were found to be relatively neutral, with Earsman Creek entering the lake being slightly higher. The decrease in pH could be a result of biological activity breaking down carbon at the bottom of the lake where oxygen is expected to be low. Because of this, the reactions that occur will result in a slight acidifying effect. The trends of DO and temperature found in and around the lake were observed to have significant seasonal changes. The relationship between DO and temperature found on the property follow Henry’s Law quite closely when considering Figure 1. Warmer water will dissolve less oxygen; as the lake warms in the summer months, the amount of dissolved oxygen naturally decreases. The oxygen levels did however spike on July 23rd, possibly due to increases of plant activity, and thereby increased levels of oxygen released during photosynthesis. Upon inspecting the difference within the lake, the different depths proved not to have a significant effect on pH, DO, or temperature (See data in Appendix I). This is likely due to the fact that the lake is fairly shallow and therefore allows for even mixing to occur.

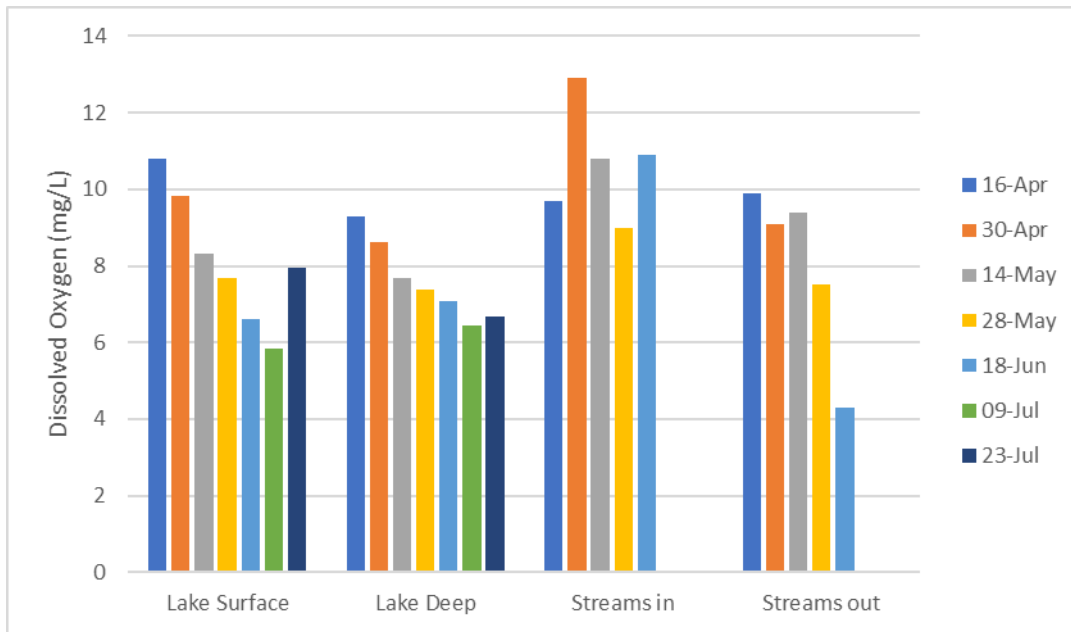
Figure 9: Average dissolved oxygen readings from Mary Lake from 16 April, 2019 to 23 July, 2019 by Van Isle Eco Consulting using Cole-Parmer temperature corrected dissolved oxygen probe.

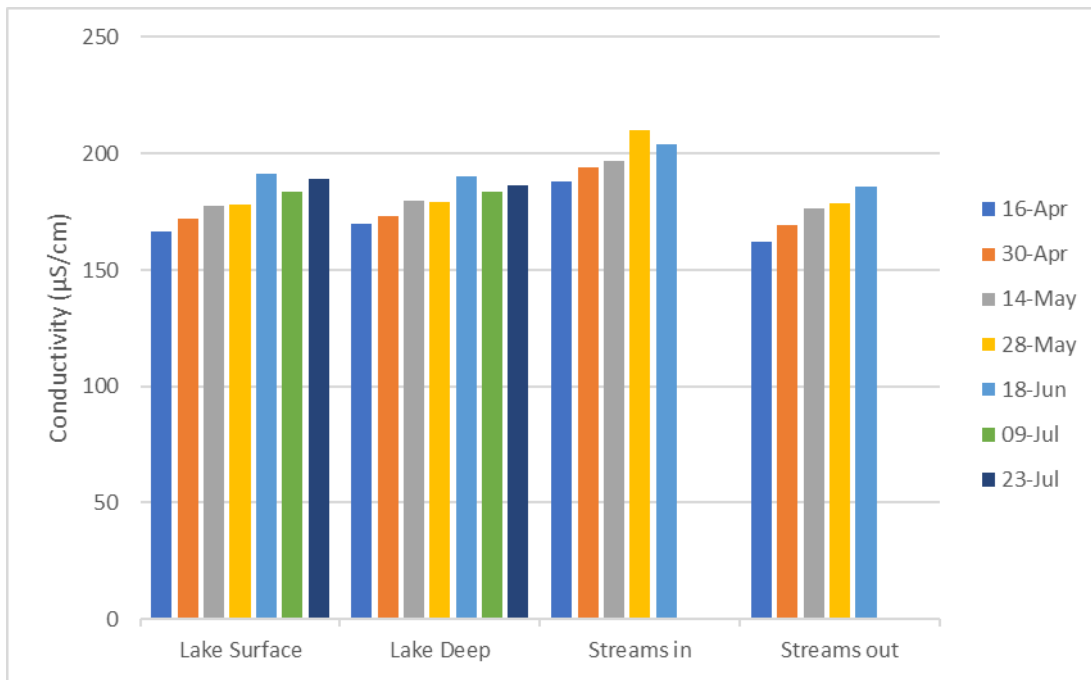
Figure 11: Average conductivity readings from Mary Lake from 16 April, 2019 to 23 July, 2019 by Van Isle Eco Consulting using Oakton PCTSTester 50 field probe.
