2023 Research Project

# Beaver Wetland Assessment

A Mary Lake Nature Sanctuary Project

Prepared for Greater Victoria Greenbelt Society  
August 16<sup>th</sup>, 2023

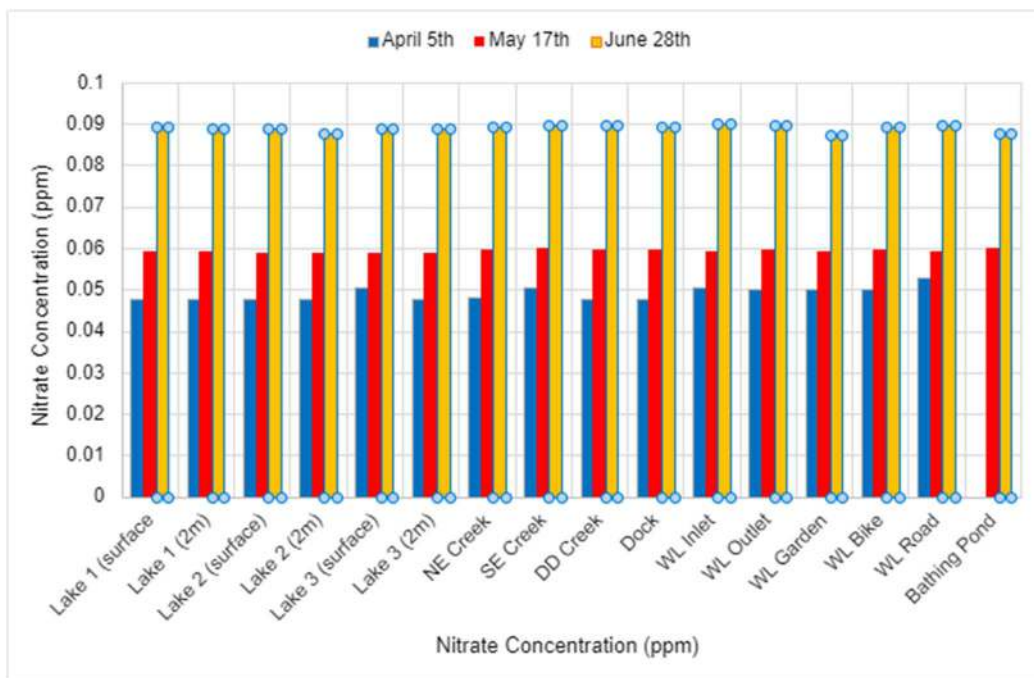
**Figure 4.2.** Nitrate results from April 5th, May 17th, and June 28th 2023, of each site location of both the wetland and lake on Mary Lake property. Results found from laboratory analysis of absorbance using a spectrometer to determine concentration via colorimetric assay.

Figure 4.2 displays the nitrate concentration in parts per million in the water samples at each of the lake and wetland sites. The figure displays data for both the April 5th analysis, the May 17th analysis, and the June 28th analysis with the inclusion of the bathing pond site in the later second lab date. Phosphates were tested for on April 5th, May 17th, and June 28<sup>th</sup>; however, every sample concentration was below the detection limit (0.01mg/L) for this method of testing. The samples had very little variation between sites on each date; however, the concentrations varied between sample dates. The concentrations increased on average 0.01ppm between the first and second sampling date. The concentrations increased on average 0.03ppm between the second and third sampling dates.

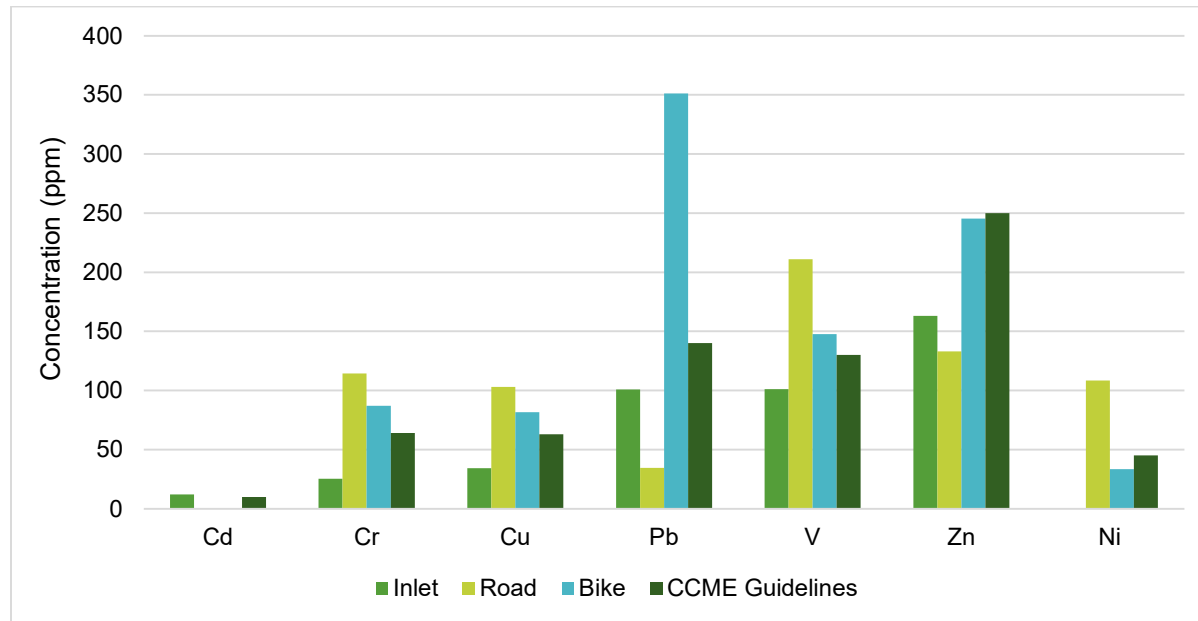
**Figure 4.12.** Average metal concentrations (ppm) in sediment by site through XRF analysis of sediments collected at the inlet, bike, and road sites by Jaeden Jones and Kyla Macilroy on April 12th and analyzed by Jaeden Jones and Harrison Craig on May 10th.

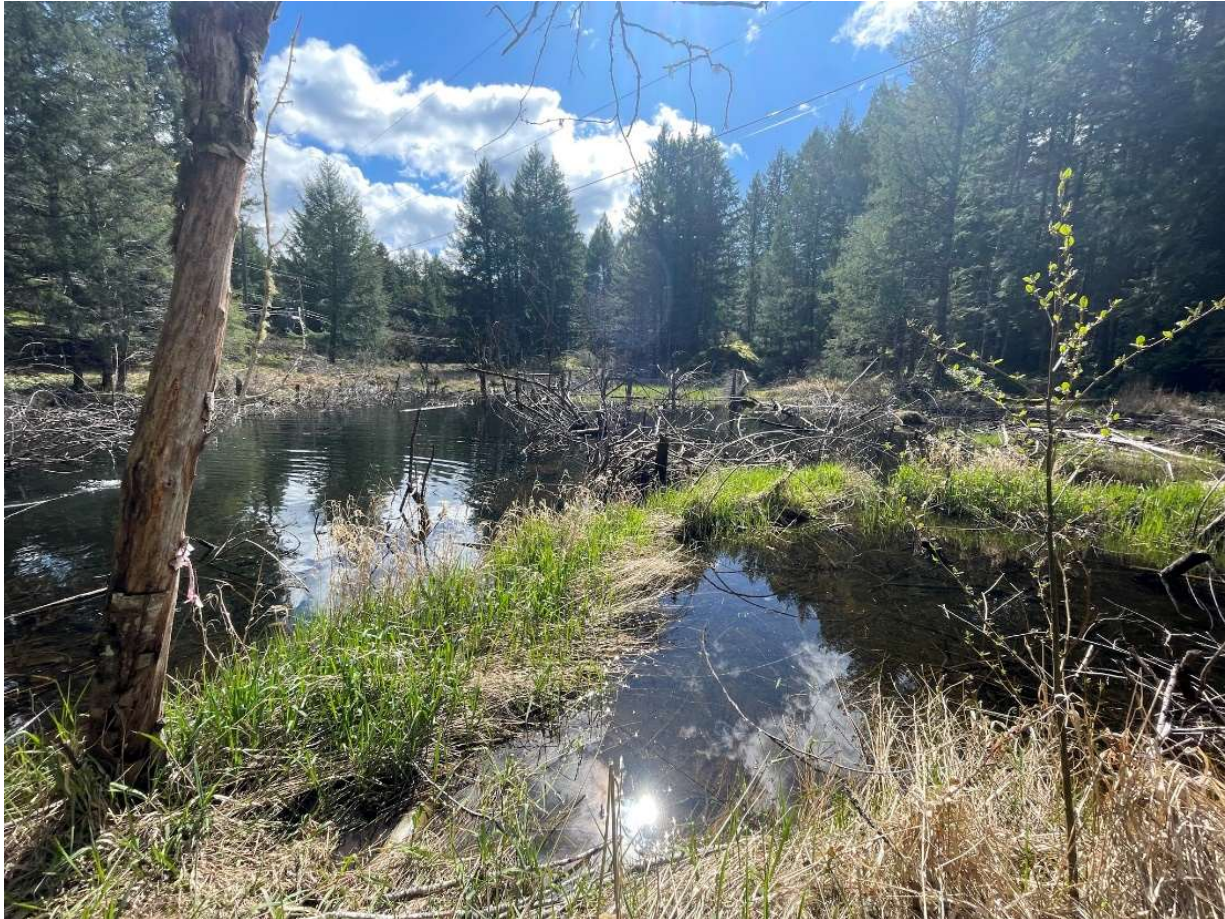
**Figure 4.18.** Image showing the open sun polygons 1-8, with deep water close to the shore; photo: Kimberly Groome.

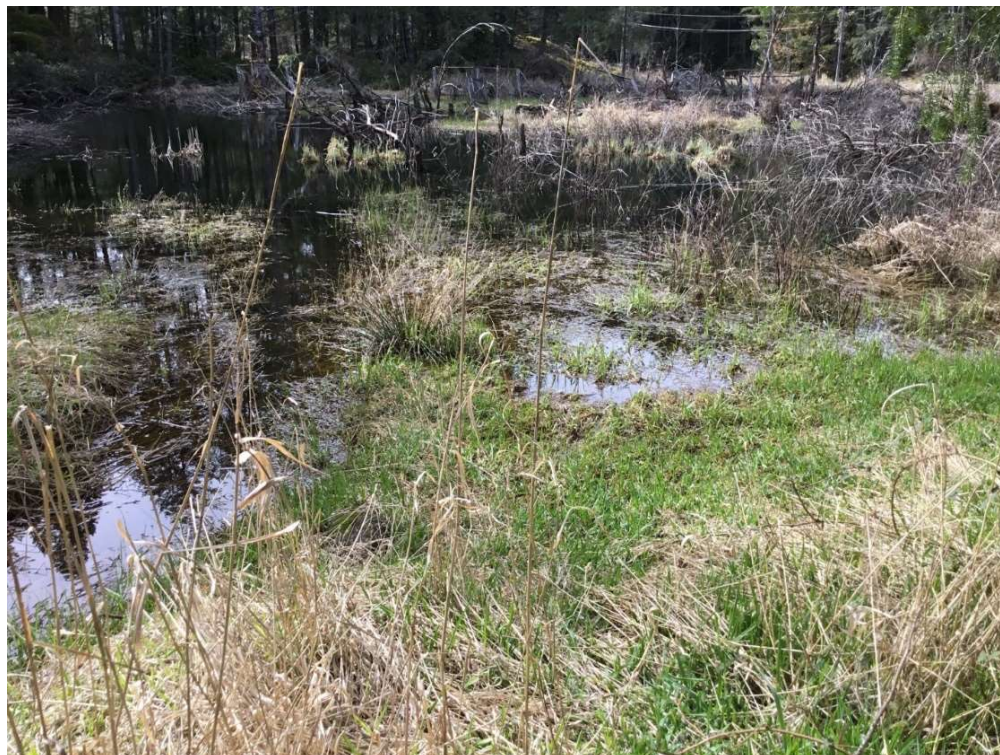
**Figure 4.19.** Image showing polygons 9-12 dominated by grass and shallow water, photo: Kimberly Groome.

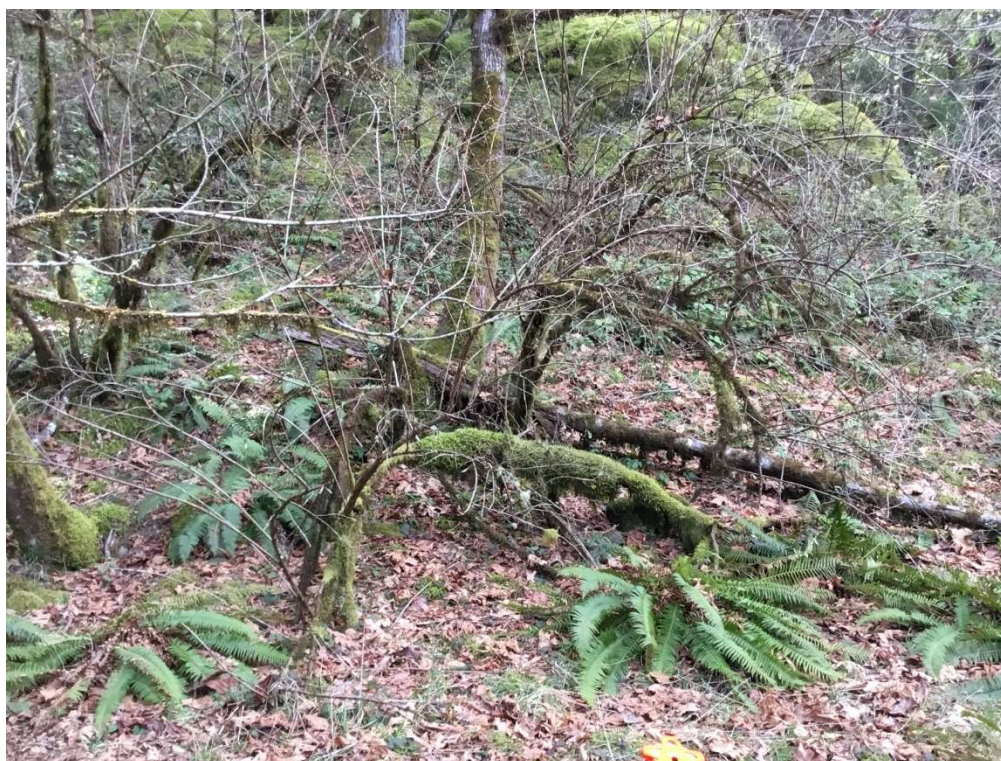
**Figure 4.20.** Image showing polygons 13-15 distinct ecosystem from the rest of the Beaver Wetland, photo: Kimberly Groome.

Millstream Creek flows southwest through polygons 1-6, it then curves fully south, where it meets up with South Earsman Creek (Figure 4.17). Other than precipitation, Millstream Creek is the source of water for the wetland. The Beaver Wetland can be broken into four distinct polygon groups based on the characteristics of the wetland and amount of sun throughout the day. Polygons 1-8 are next to an old overgrown road closest to the inlet and outlet that is Millstream Creek; they are dominated by shrubs <2m tall, and grass (Figure 4.18). These polygons have the greatest number of all the plant species in the wetland comparatively (Figure 4.18) and receive a lot of sun. Polygons 9-12 are dominated by grass: the area here sees the most change throughout the spring, the land is flatter, and the water has large surface area rather than depth (Figure 4.19). Due to the amount of grass cover, there were no observed aquatic plants in these polygons (Figure 4.19). Polygons 13-15 are an interesting ecosystem; there are more ferns and some taller shrubs, as the wetland transitions into more tree cover (Figure 4.20). Polygons 16-23 are predominantly shade covered (Figure 4.21); however, the species distribution is similar to polygons 13-15 (Figure 4.20).

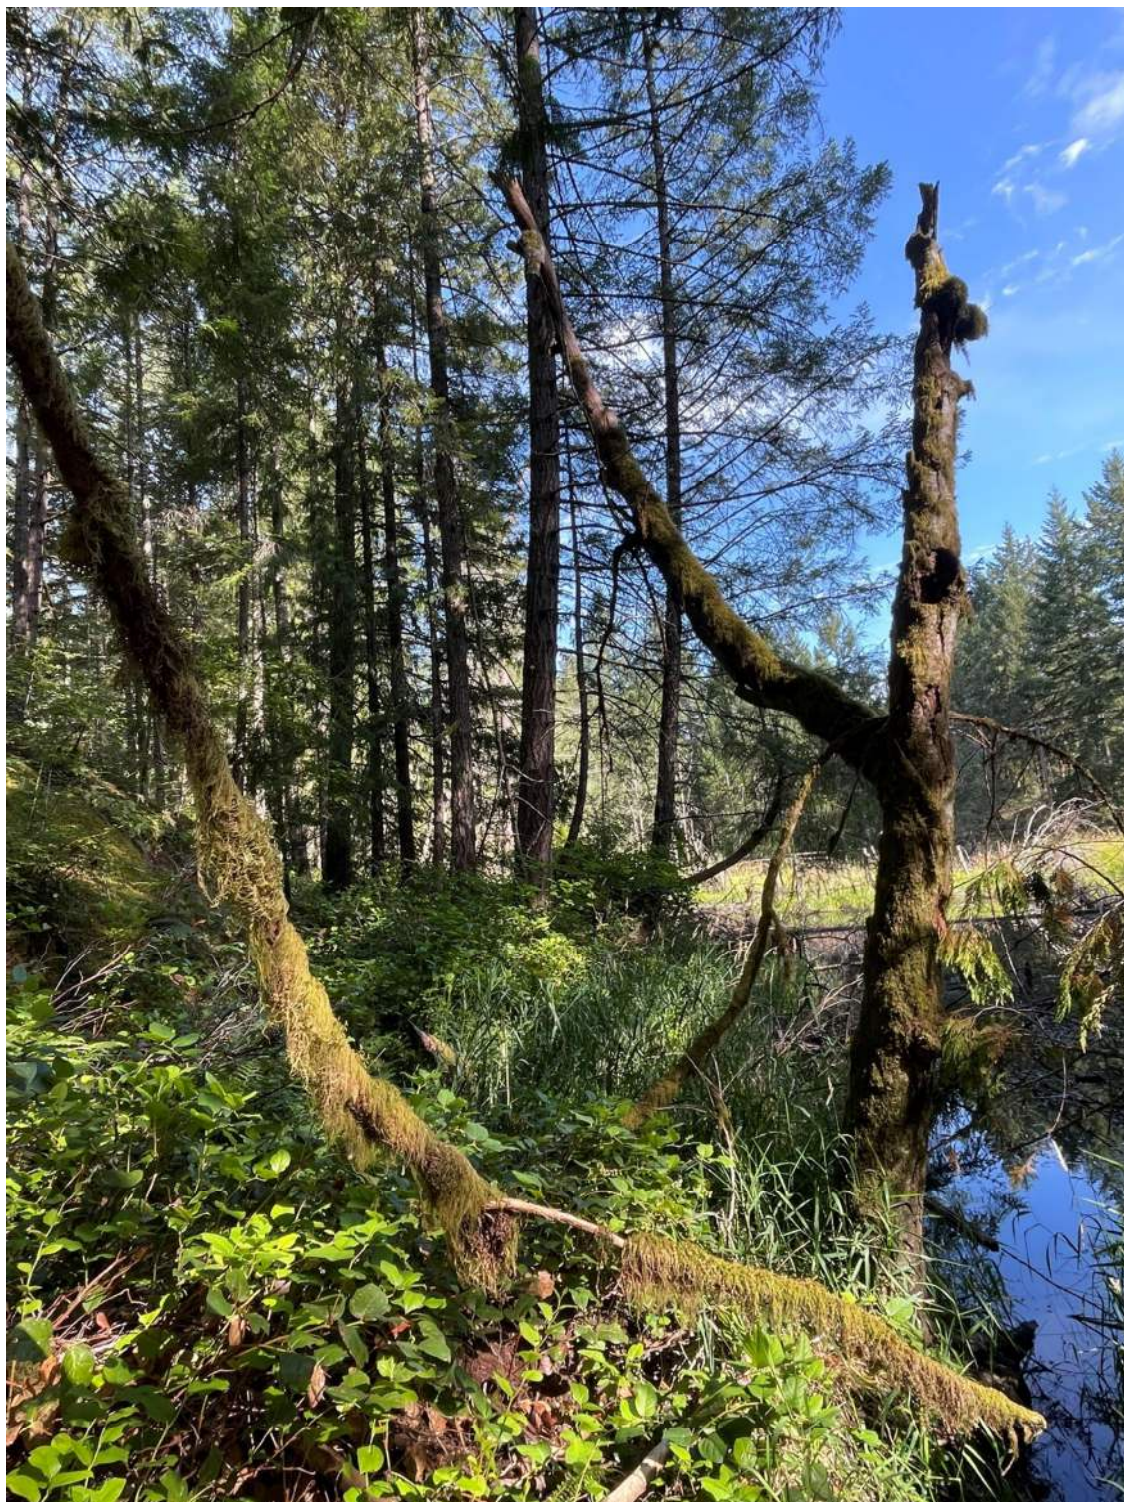
**Figure 4.21.** Image showing polygons 16-23 ecosystem compared to the rest of the Beaver Wetland, this site is predominantly shade covered compared to the sun covered polygons 1-8 in the background, photo: Kimberly Groome.

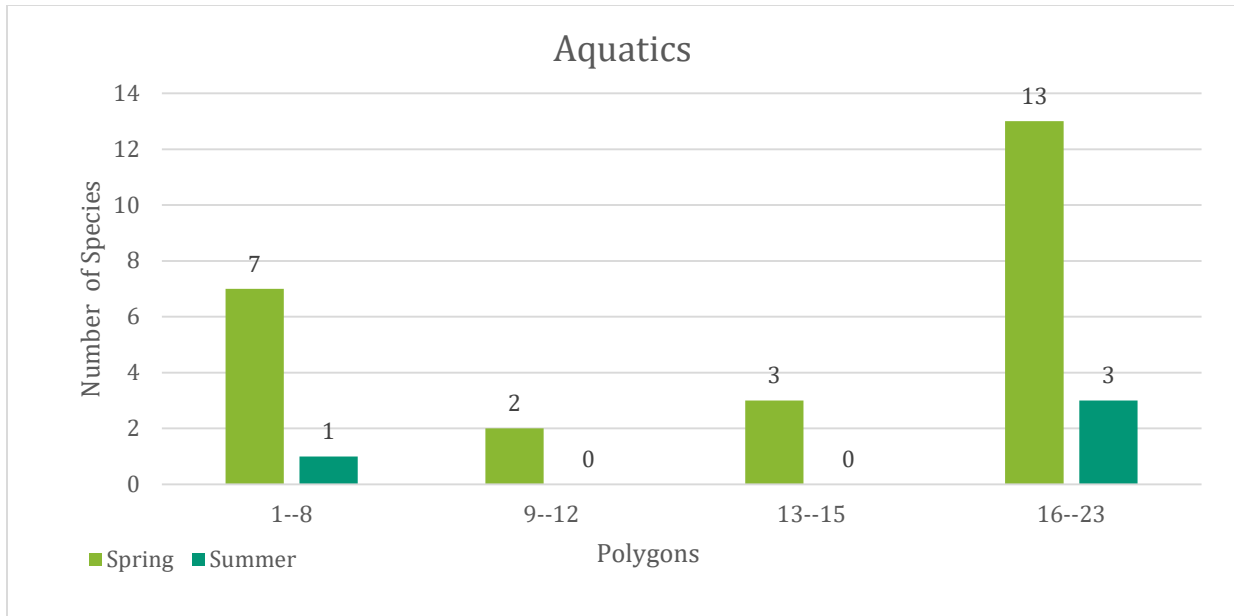
**Figure 4.26.** The number of aquatic species present in each polygon group, 1-8, 9-12, 13-15, and 16-23 found during the spring (April 26th and May 3rd, 2023) and summer (June 21st and July 12th, 2023) assessments.

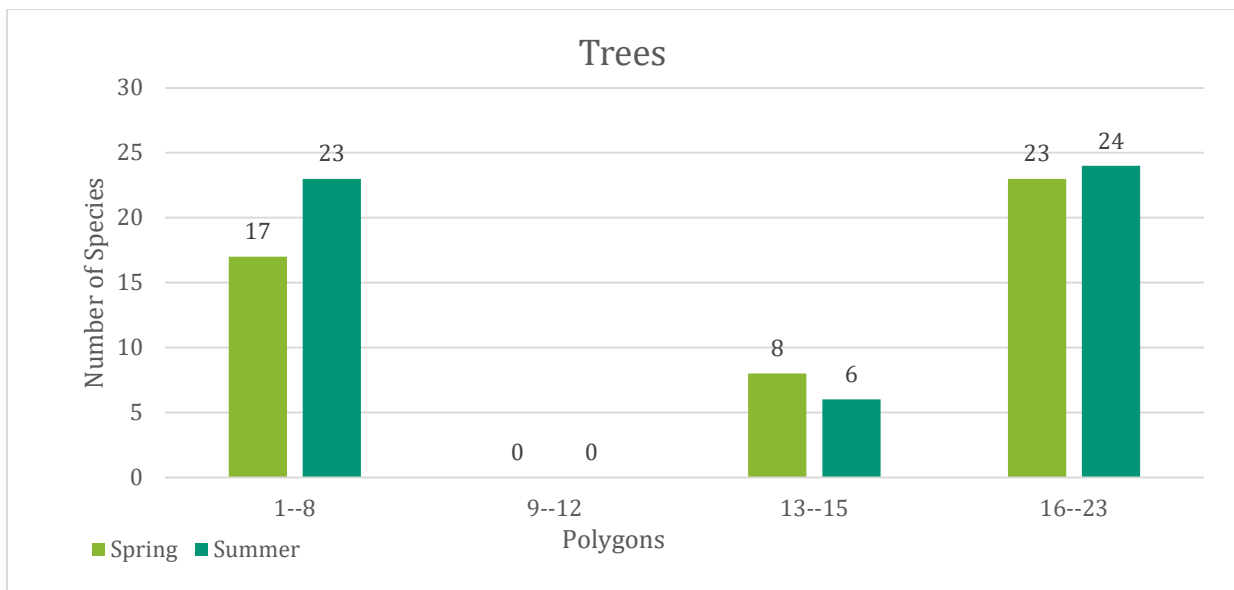
**Figure 4.27.** The number of tree species present in each polygon group, 1-8, 9-12, 13-15, and 16-23 found during the spring (April 26th and May 3rd, 2023) and summer (June 21<sup>st</sup>, July 12<sup>th</sup>, and August 2<sup>nd</sup>, 2023) assessments.

The total number of species found around the Beaver Wetland at MLNS was 109, of those species six were shrubs 2-10m tall, 68 were shrubs <2m, 14 were species of moss and lichen, seven were aquatic species, and 14 were grass species found during the summer assessment (Table 4.5). A full list of these species can be found in the Appendix tables A.27 to A.30. Shrubs <2m had the most diversity out of any of the other plant categories. In spring there were 69 species, and in summer there were 63 species in polygons 1-8 (Table 4.6, Figure 4.22). Polygons 16-23 had the next highest species diversity of shrubs 2-10m with 58 species in the spring and 30 species in the summer, which is also the biggest change in diversity out of any polygon group (Table 4.6). For the shrubs 2-10m, all polygons had ten or less different plants, which was fairly consistent for polygons 1-8, 9-12, and 13-15 (Table 4.6, Figure 4.23). For polygons 16-23 the number of different species dropped from ten to three from spring to summer (Table 4.6). This was also the case for moss and lichen species, while all polygons experienced a loss of species, the first three polygon groups had relatively stable numbers while polygons 16-23 went from ten species in the spring to zero in the summer (Table 4.6, Figure 4.24). The grass species found at the Beaver Wetland all saw an increase from spring to summer in species diversity in all polygon groups except, again group 16-23 (Table 4.6, Figure 4.25). The aquatic species were not abundant around the wetland, and in all polygons, there was a drop to almost none being present in the summer (Table 4.6, Figure 4.26). Trees were observed in all polygons except 9-12; polygons 1-8 saw an increase in the number of trees present, while polygons 13-15 saw a loss of two trees, and polygons 16-23 observed one additional tree (Figure 4.27).

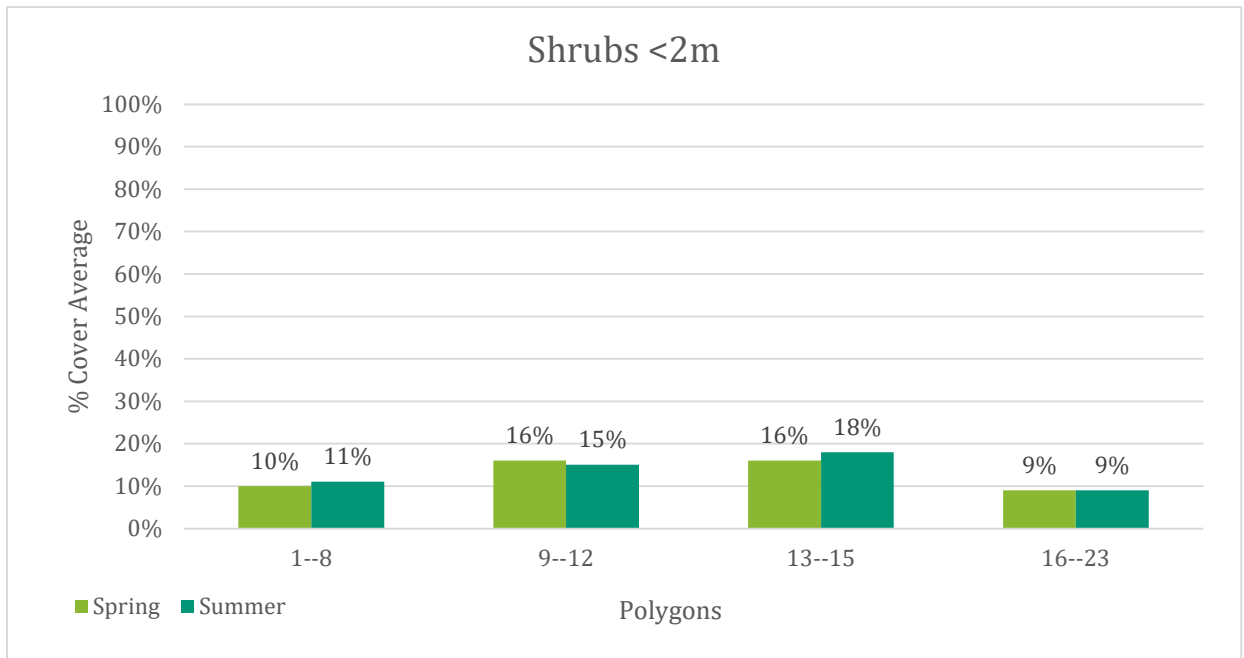
**Figure 4.29.** The % cover average of shrubs <2m species present in each polygon group, 1-8, 9-12, 13-15, and 16-23 found during the spring (April 26th and May 3rd, 2023) and summer (June 21st and July 12th, 2023) assessments.

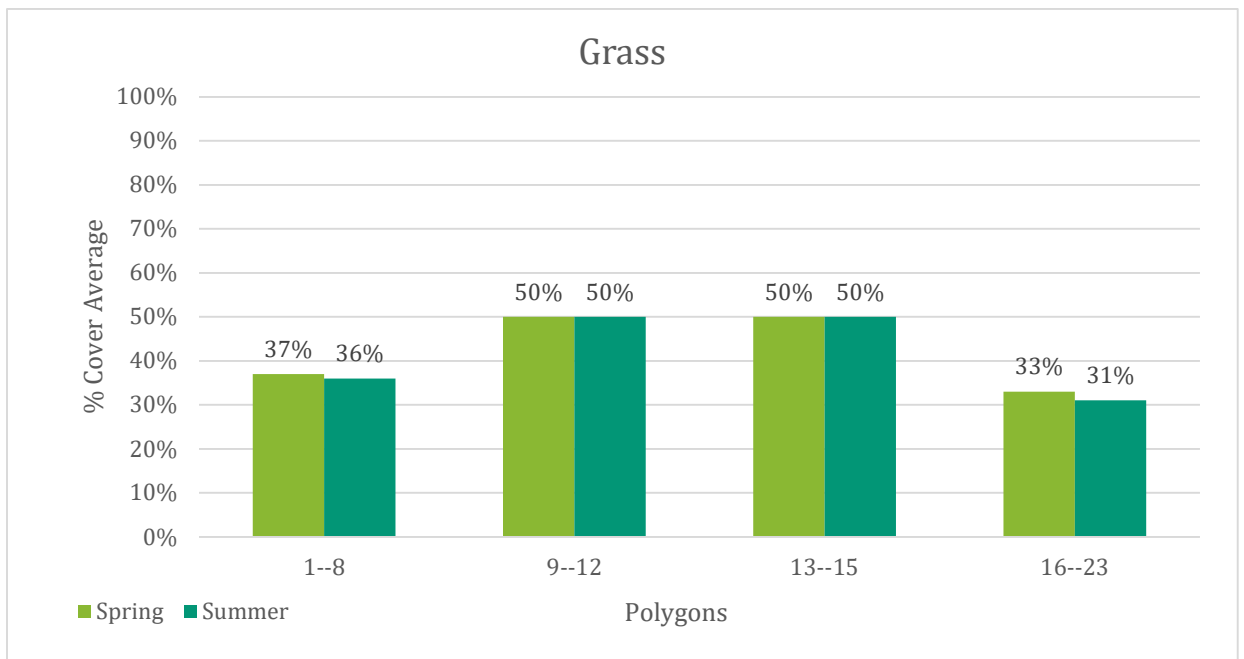
**Figure 4.31.** The % cover average of grass species present in each polygon group, 1-8, 9-12, 13-15, and 16-23 found during the spring (April 26th and May 3rd, 2023) and summer (June 21st and July 12th, 2023) assessments.

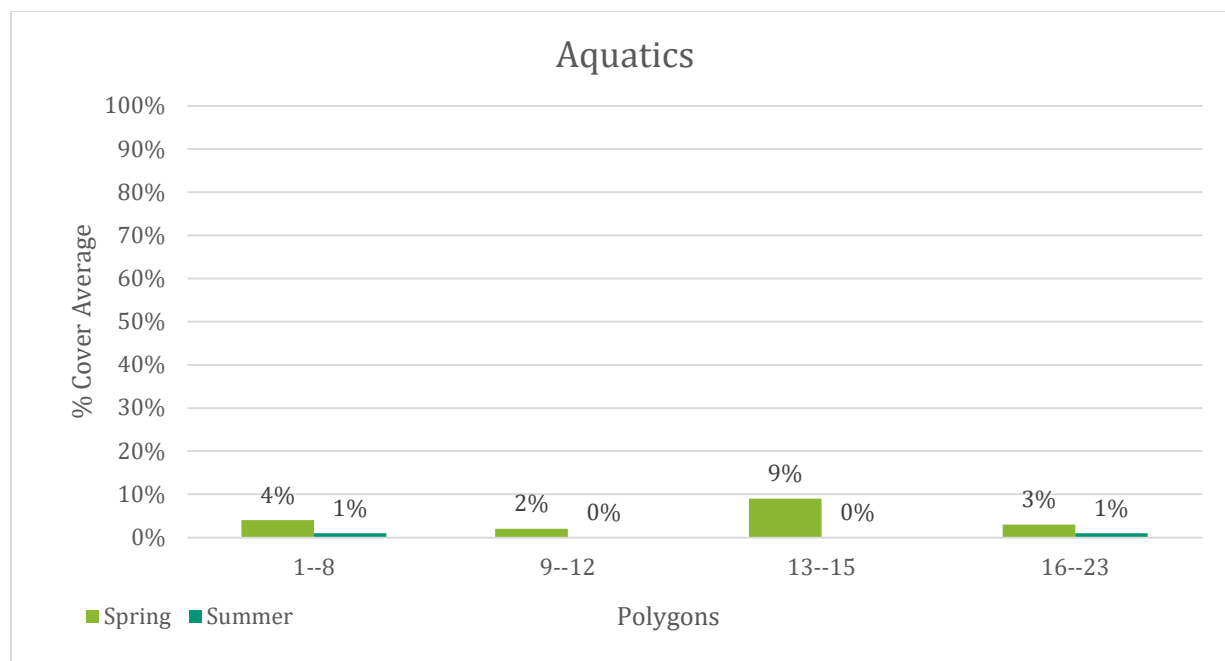
**Figure 4.32.** The % cover average of aquatic species present in each polygon group, 1-8, 9-12, 13-15, and 16-23 found during the spring (April 26th and May 3rd, 2023) and summer (June 21st and July 12th, 2023) assessments.

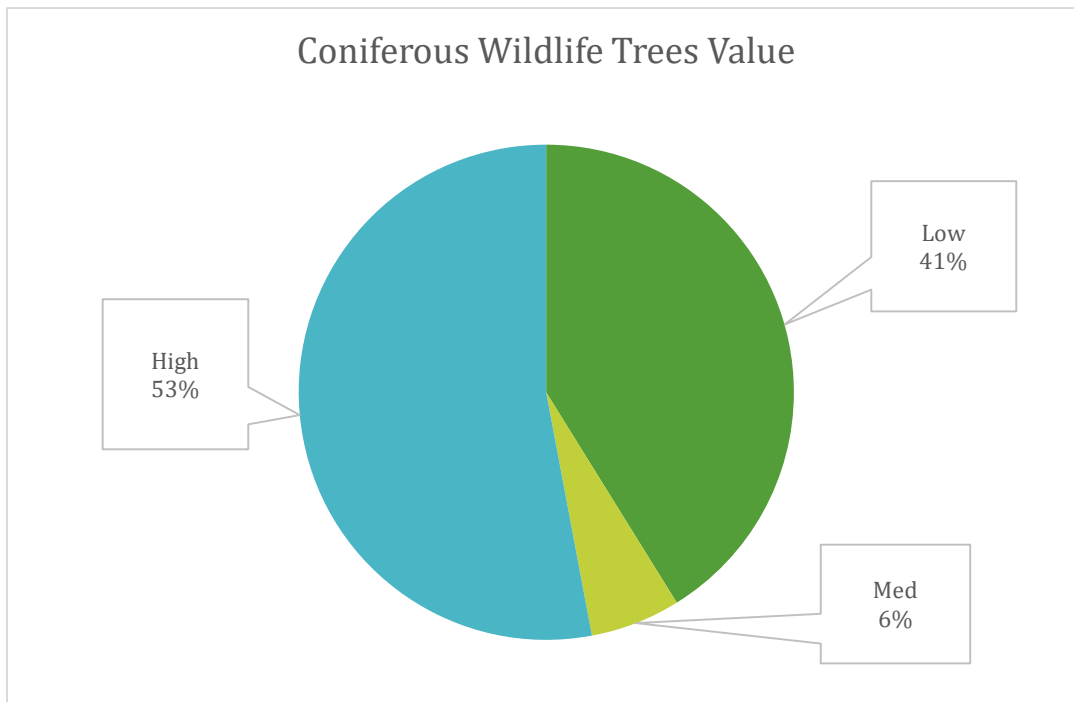
**Figure 4.34.** Coniferous wildlife trees around the Beaver wetland based on value, 53% high, 6% medium, and 41% low value.

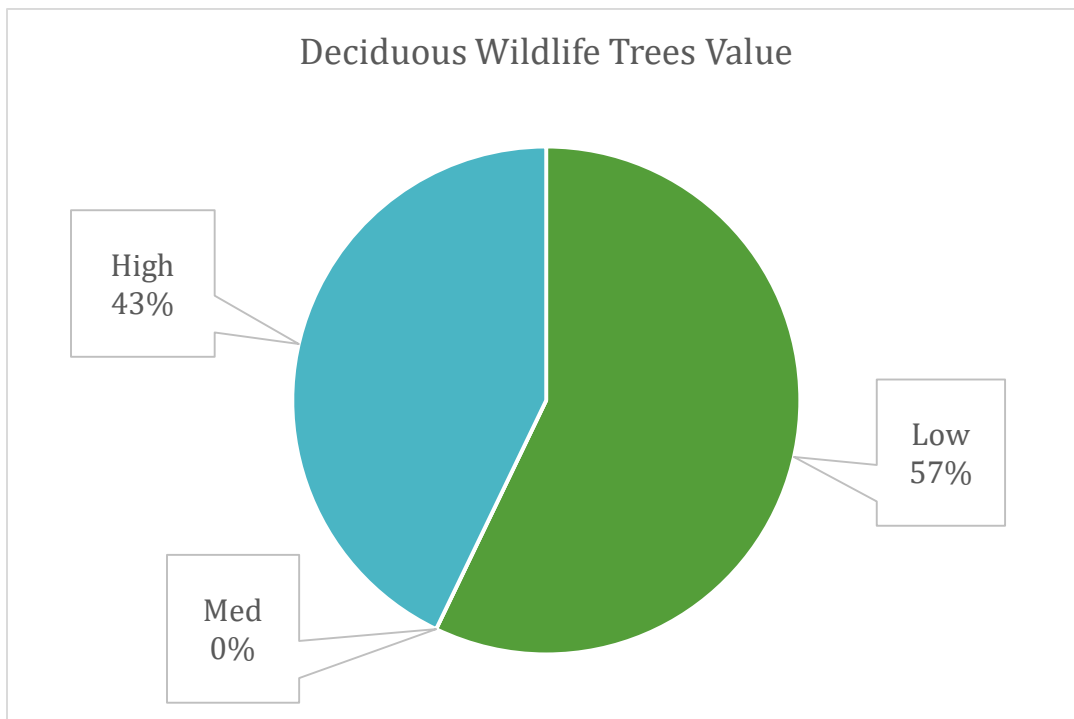
**Figure 4.35.** Deciduous wildlife trees found around the Beaver wetland based on value; 43% high, 0% medium, and 57% low value.

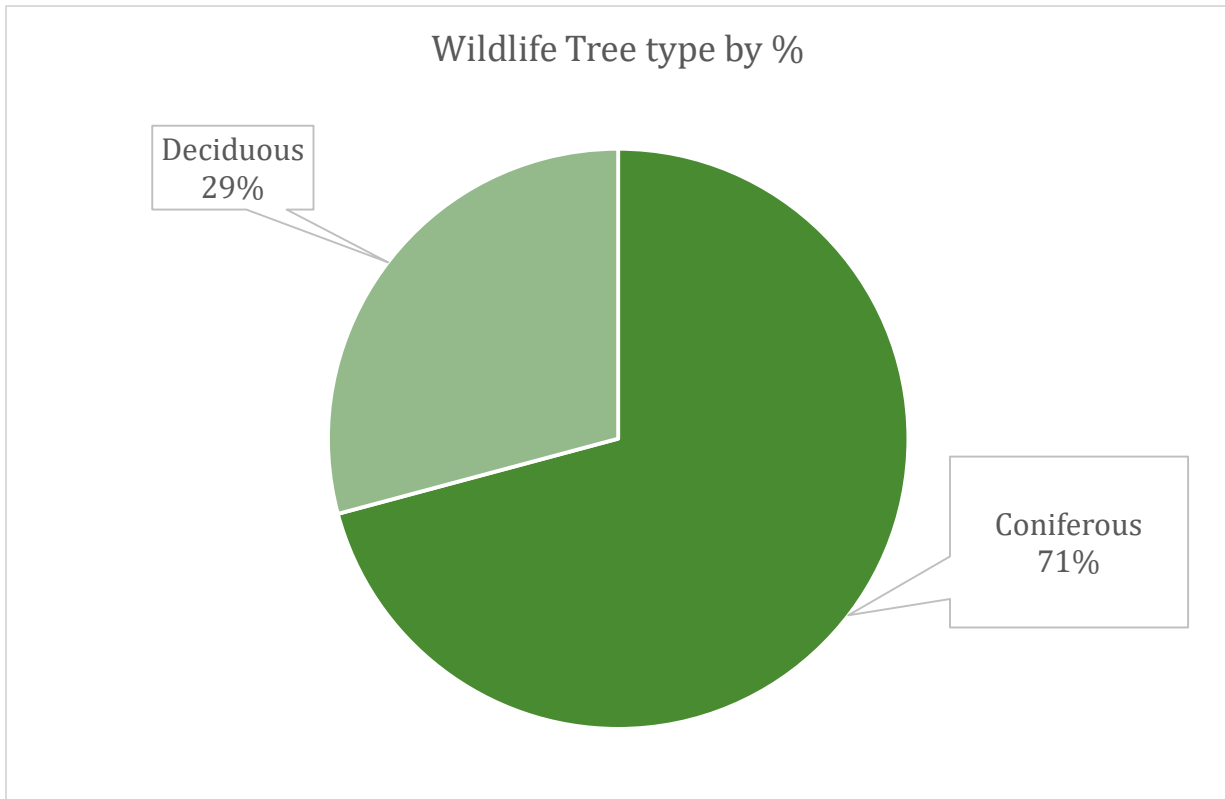
**Figure 4.36.** Percent of wildlife trees found around the Beaver Wetland by type, 29% deciduous and 71% coniferous

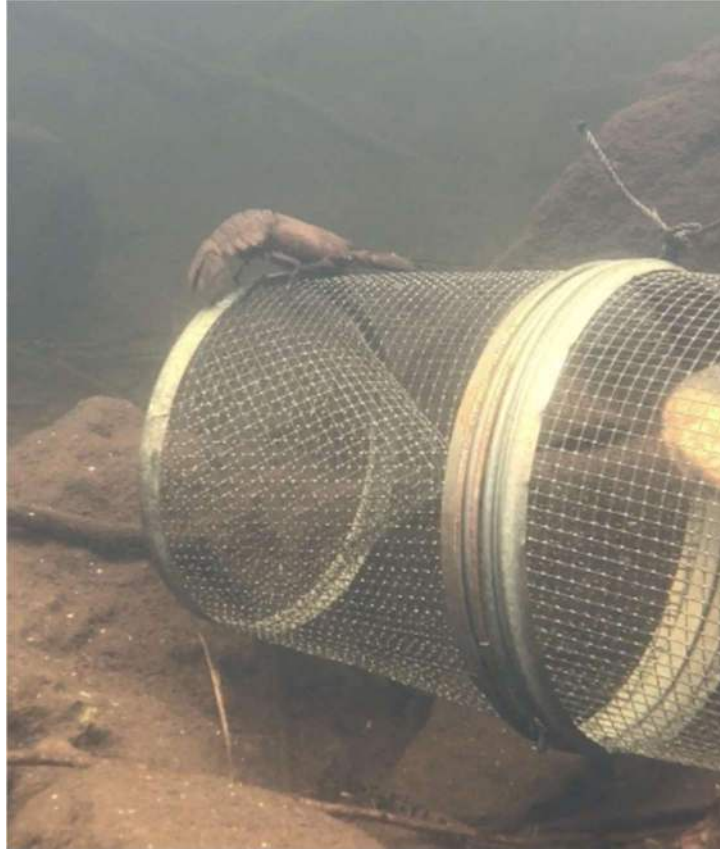
**Figure 4.37.** Crayfish observation at WL-Outlet site during gee trap removal on June 21, 2023.

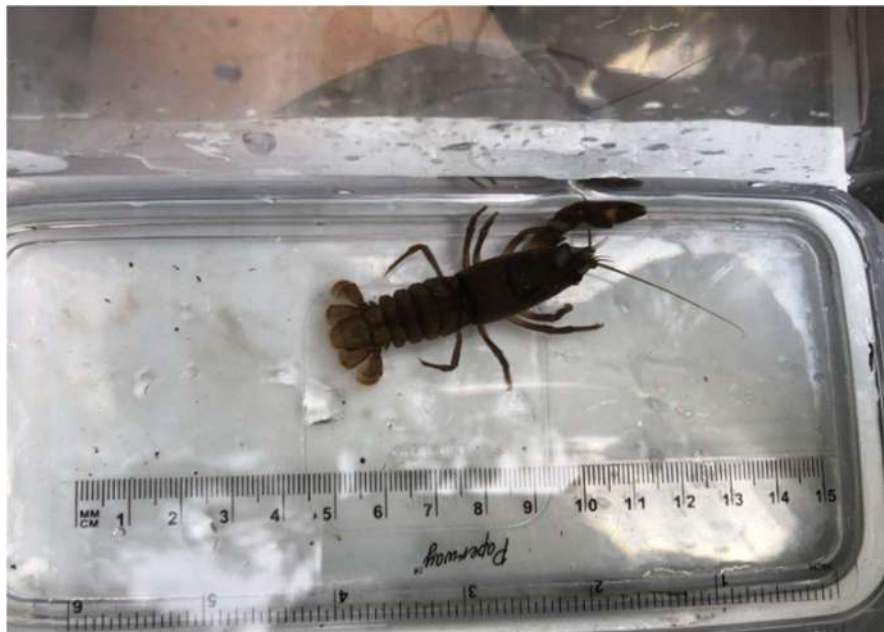
**Figure 4.38.** Crayfish observation at WL-Inlet site in Millstream Creek during walkthrough of area on June 21, 2023.

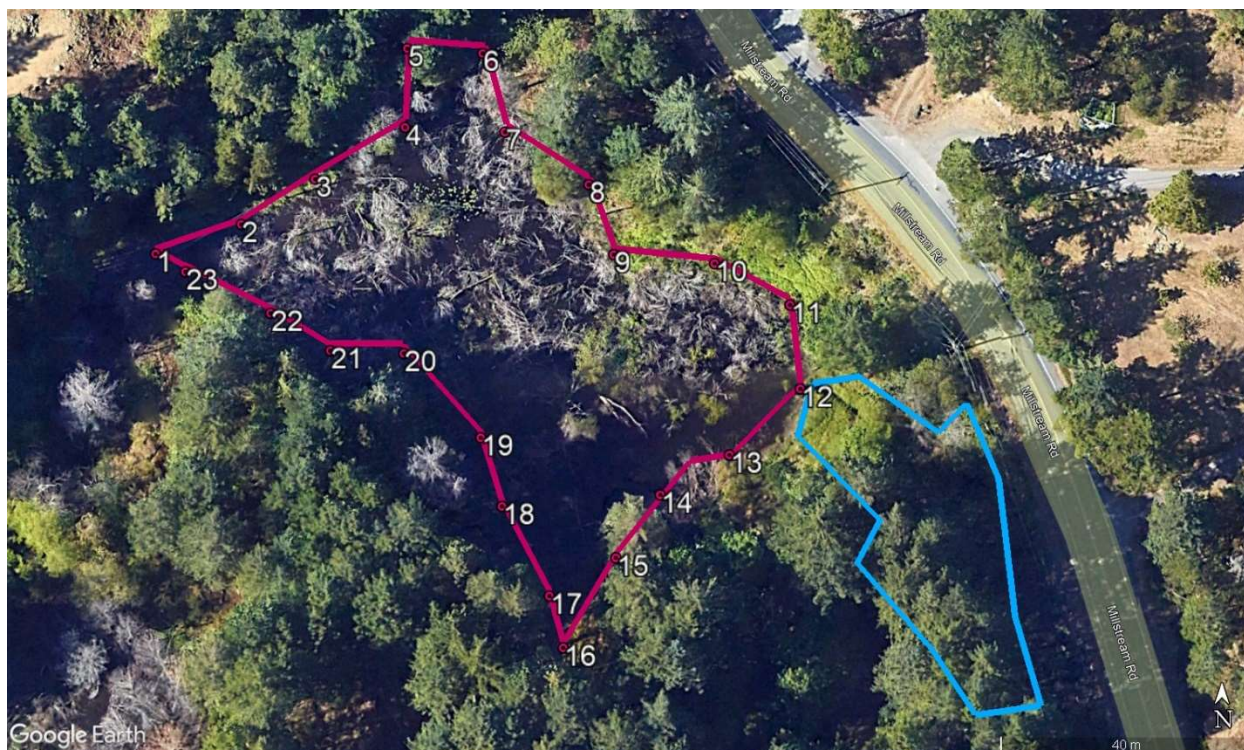
**Figure 5.2.** Map of the vegetation polygons at the Beaver Wetland at Mary Lake Nature Sanctuary, the pink outline is the main wetland focused on and blue outline is the west arm not focused on for safety reasons; Map made in Google Earth Pro by Kimberly Groome; May 29, 2023, NAD 83 WSGS U10.
